Final Report on Alternative Chromate-Free Wash Primers

ARL-TR-3932

September 2006

**Pauline Smith, Kestutis Chesonis, Christopher Miller,
and John Escarsega
Weapons and Materials Research Directorate, ARL**

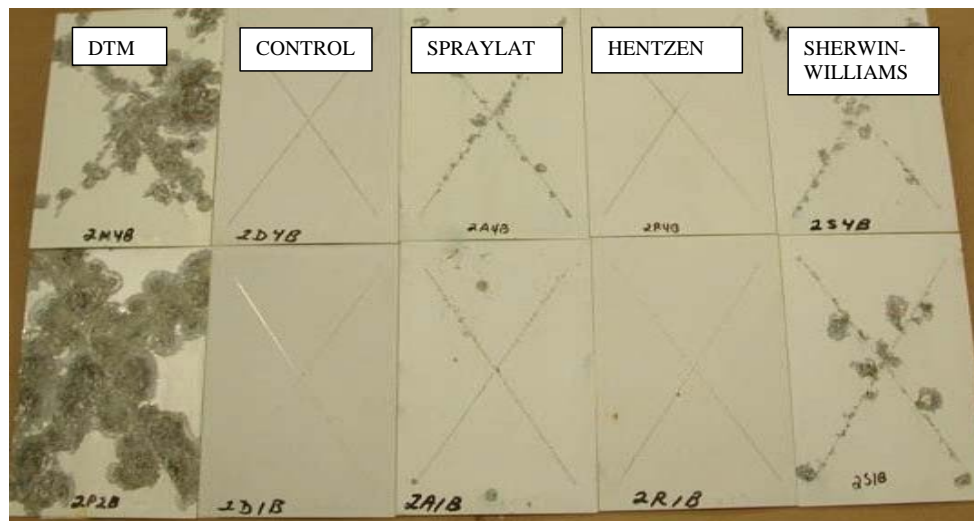
Al 2024-T3 is mainly used on aircraft and missiles and is the least corrosion resistant of the series. For Al 2024-T3, as shown in table 10, the alternative systems have 40–60% of the control protection after 1088 hr in salt fog, while DTM has 10%, and at 2088 hr, DTM has 0% protection. At 44 cycles in the GM 9540P, the control offers 90% protection, while the three alternative systems offer ~50%, and the DTM offers ~10%. The separation between 44 cycles and 100 cycles was marginal.

Figure 1. GM 9540P results for Al 2024-T3.

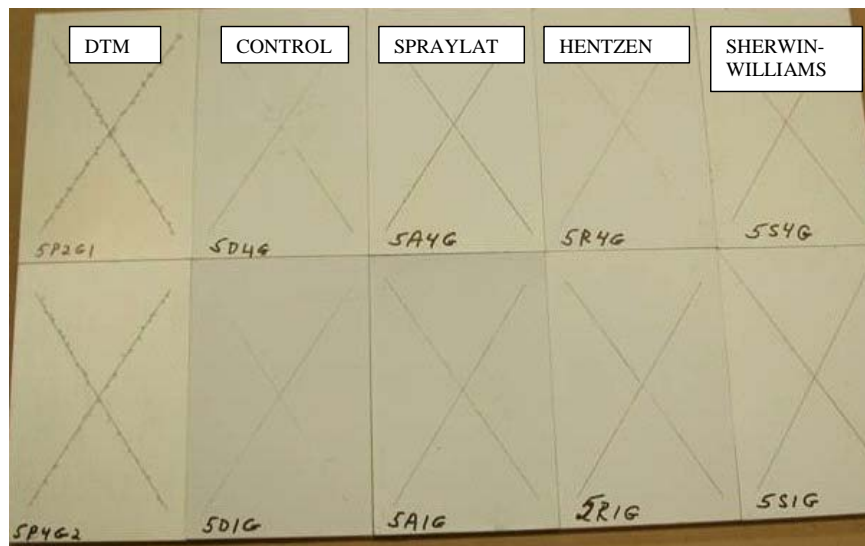
Al 5083-H231 does well in corrosion due to its protective oxide layer and is normally utilized on armor and tactical ground systems. In table 11, the slight change in data from 44 to 100 cycles in the GM chamber shows that two vendors are equal to the control. In ASTM B 117, the DTM offered 30% protection over the control after 2088 hr.

Figure 2. GM 9540P results for Al 5083-H231.

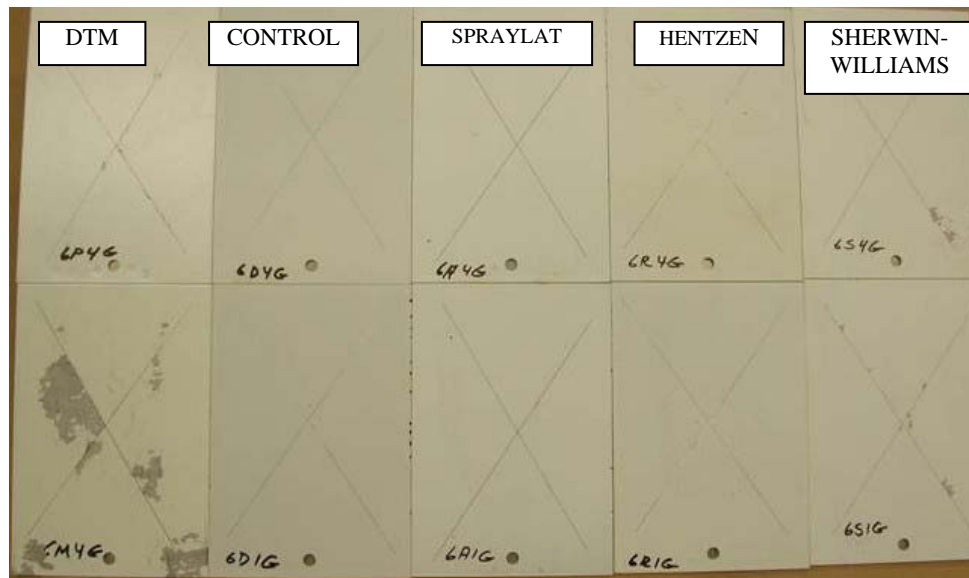
Al 6061-T3 is mainly used on components, and, as seen in table 12, all of the pretreatments performed well on Al 6061, showing little or no damage to the scribed region. DTM has 0% protection at 44 and 100 cycles, while the three vendors and the control offer 90% of corrosion protection. Additionally, the salt-fog environment demonstrates that the three vendors and the control provide 90% protection, while the DTM offers 50%.

Figure 3. GM 9540P results on Al 6061-T3.

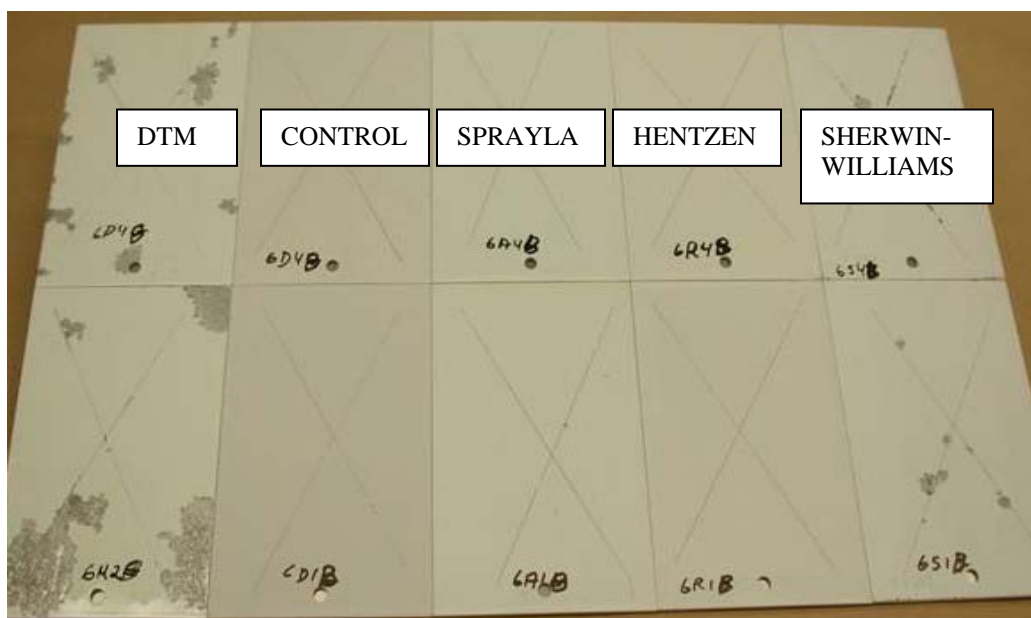
Figure 4. ASTM B 117 results on Al 6061-T3.

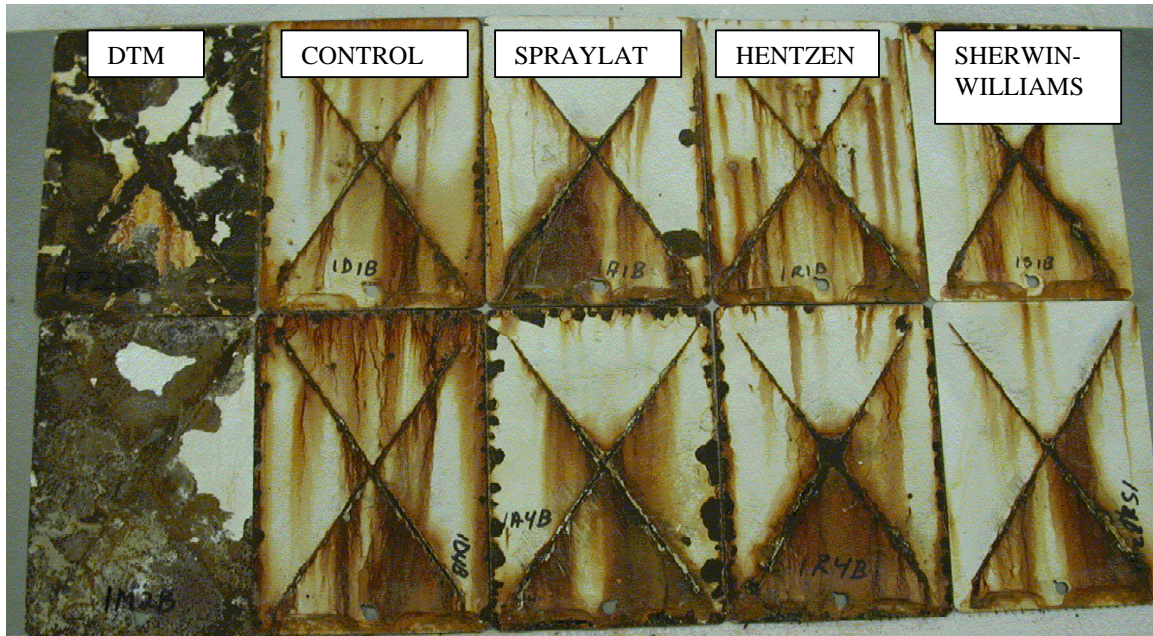
The coated steel panels performed differently from the aluminum alloys, showing greater rust and surface corrosion. The distinction is shown in table 14 for 1000 hr in salt fog, where the three vendors and the DTM are inferior to the control.

Figure 5. ASTM B 117 results on CRS 1080.

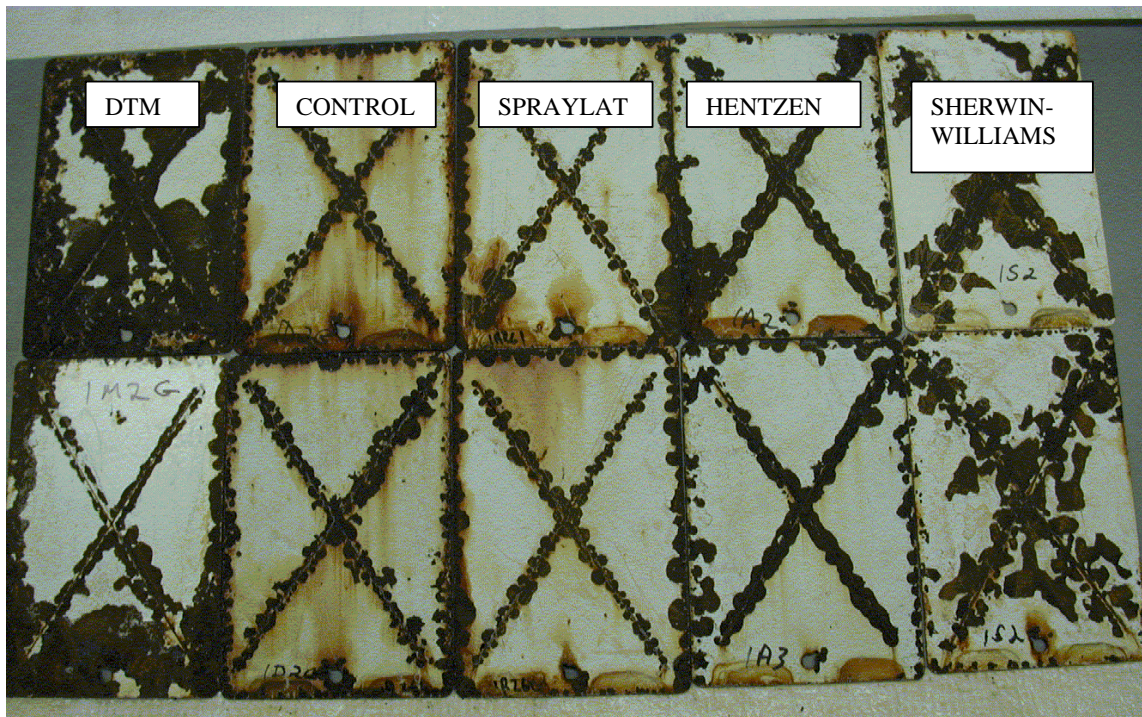
For the GM 9540P specification, 100 cycles was the best separator, with the DTM providing 0% protection. Therefore, the better performers on steel were easily observed. Most films were intact outside the scribed areas. The four treated surfaces showed similar corrosion degradation at the scribed areas and no evidence of blisters. The untreated surface (DTM) showed 90% delamination of the panel. Figures 1–6 show examples of samples exposed in both chambers.

Figure 6. GM 9540P results on CRS 1080.

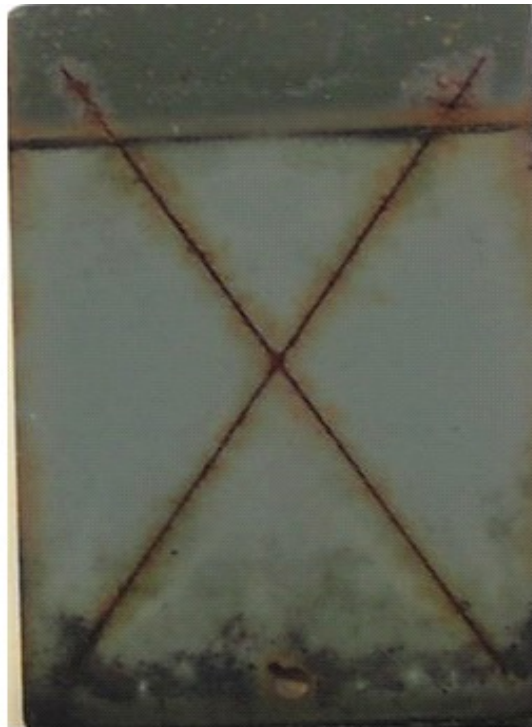
Figure 7. Vendor after 613 days, 1S2 F2.

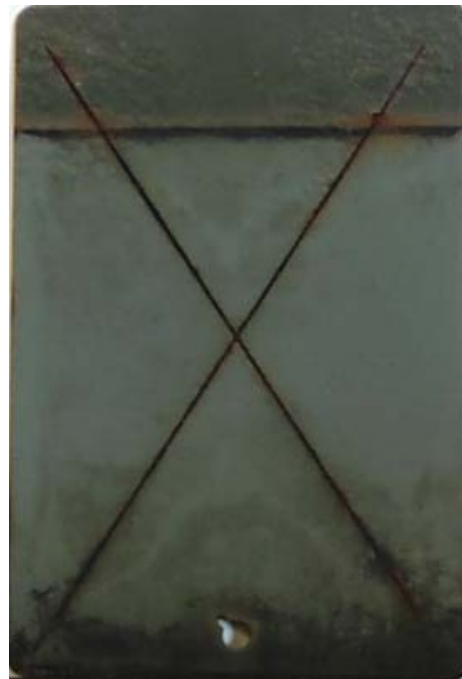
Figure 8. Control after 613 days, 1D4 F1.

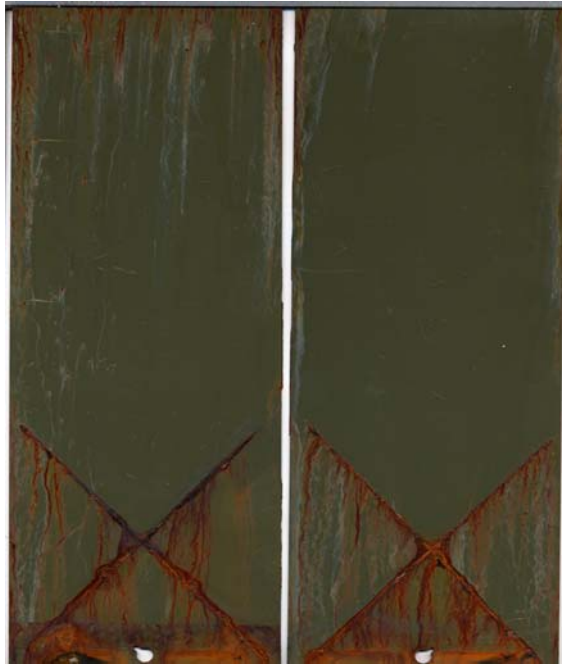
Figure 16. ASTM B117 after 1008-hr exposure. Steel panel without wash primer and with Sherwin Williams' KemAqua.

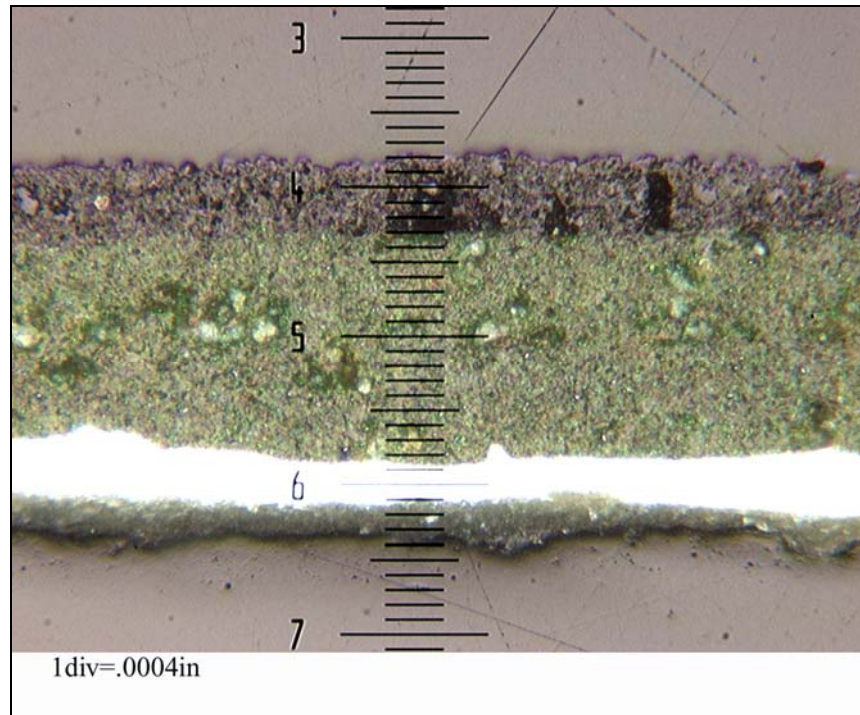
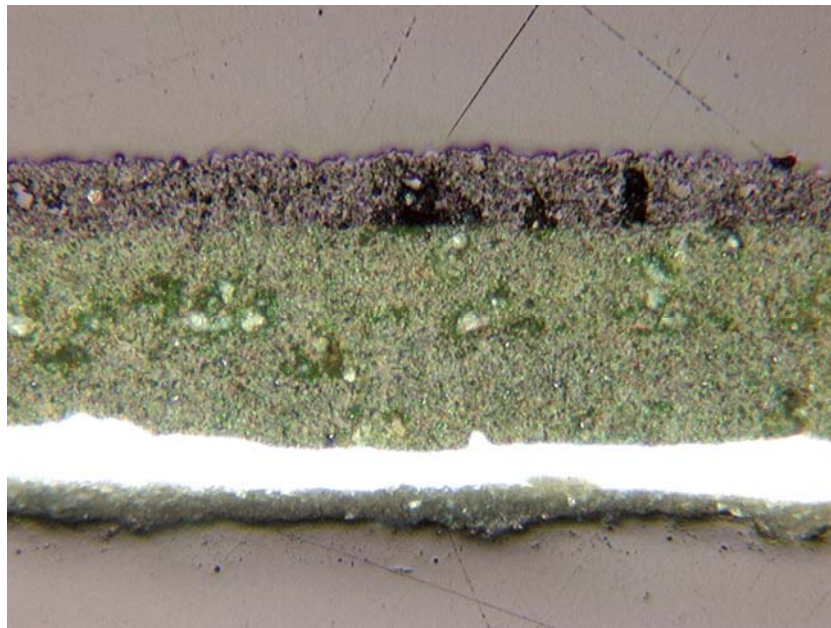
The micrographs presented in figures 22 and 23 depict the coating layers that are present on the paint chip. The top two layers appear to be black and green CARC topcoat. The third layer down

appears to be a white primer, and the bottom layer appears to be the alternative wash primer (Sherwin Williams' Kem Aqua). No polyester filler appears to be present on the chip as noted by RDEC. In figure 22, each division of the ruler is equivalent to 0.0004 in. The average thickness of the alternative wash primer remaining on the chip is approximately 0.001 in.

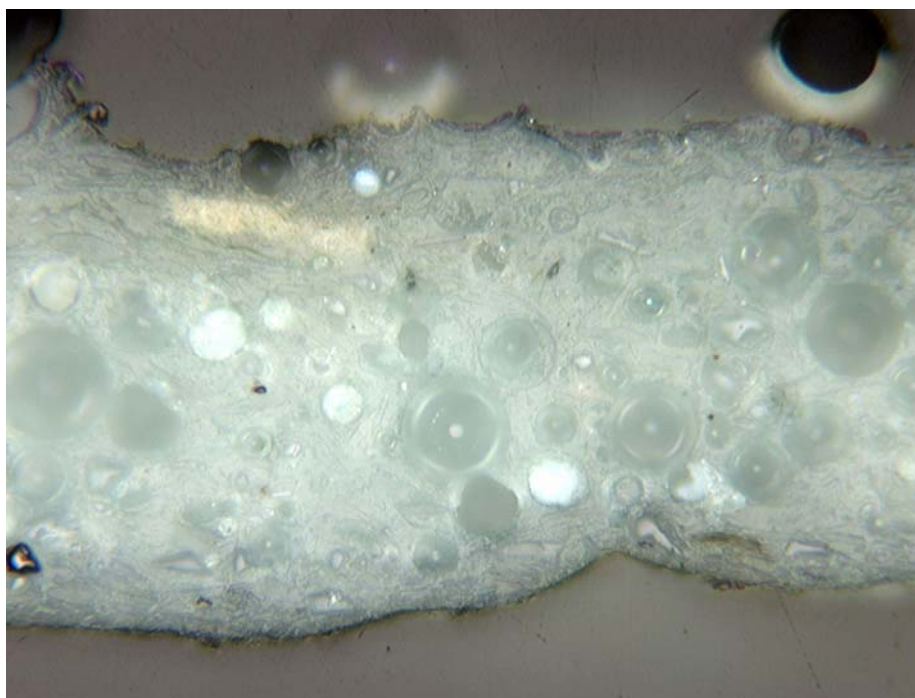
Figure 24 is a micrograph of the polyester filler. It does not appear that any of the polyester filler material shown in figure 24 is present underneath the wash primer layer on the paint chip. The absence of any polyester filler on the paint chip indicates a lack of adhesion between the alternative wash primer and the polyester filler material.

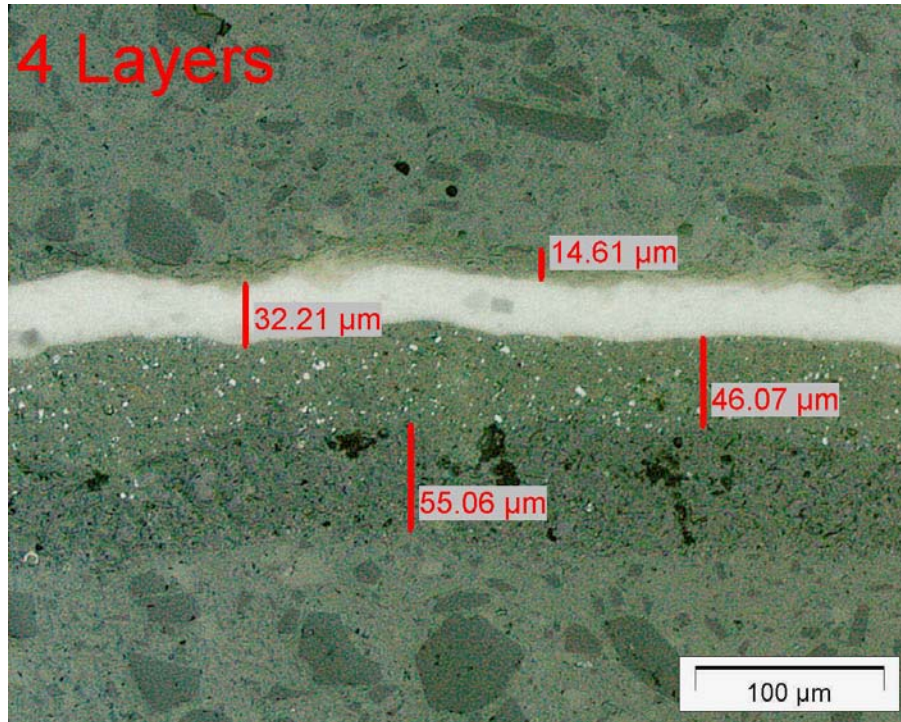
Figure 25. Micrograph of paint chip removed from Patriot ECS shelter with alternative wash primer.

The results of this analysis indicate an adhesive failure between the water-reducible wash primer and the polyester filler. Possible causes include material incompatibility between the water-reducible wash primer and the polyester filler or contaminants on the surface of the polyester filler prior to the application of the water-reducible wash primer. The paint chip from the new water-reducible wash primer showed four layers of coating while the control sample showed three coatings.

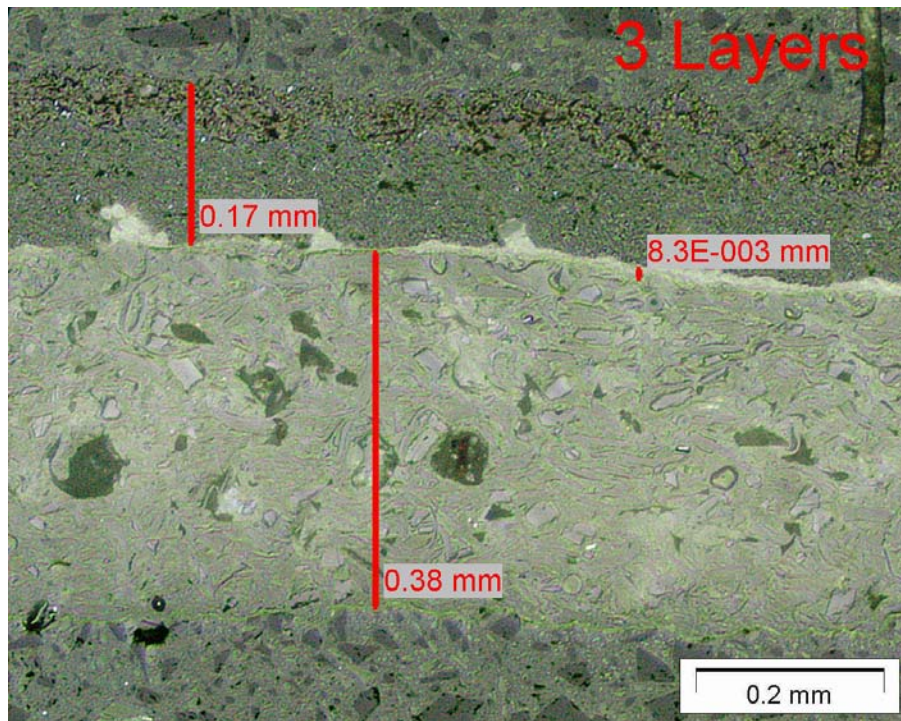
Figure 26. Micrograph of paint chip removed from Patriot CRG shelter with control wash primer.

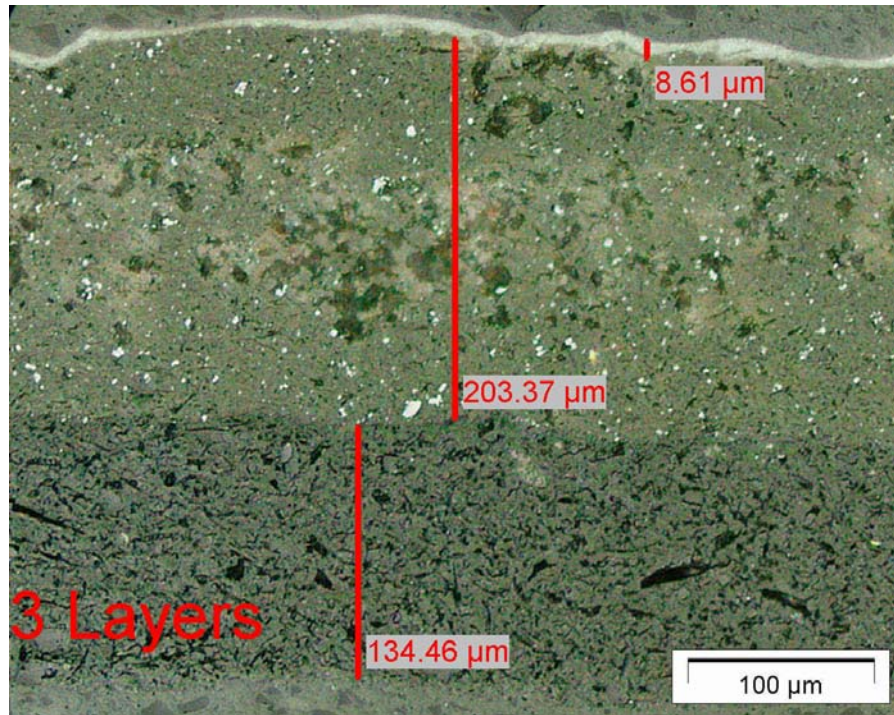
Figure 27. Micrograph of paint chip removed from Patriot ECS shelter with DOD-P-15328 wash primer.

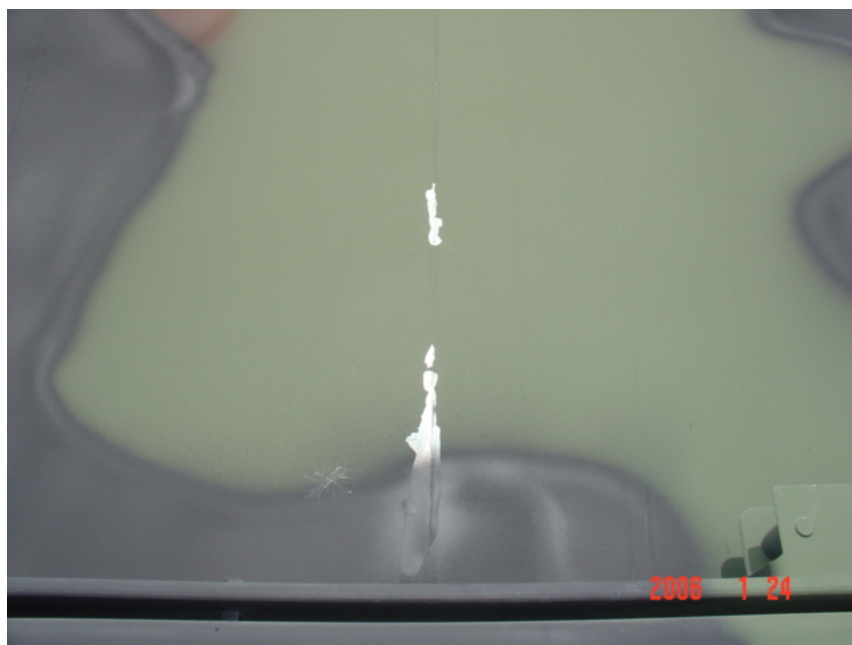
For the ECS serial no. 630106, overhaul date 05/05, there were two areas of paint adhesion failure on the outside of the vertical seam where the paint had peeled away or delaminated 1/4–1 in from the seam. Film delamination occurred only at the seam and only where the polyester filler was applied. Rivet head outlines could be seen along the entire seam. Expansion and contraction forces along the butt seam may be a contributing factor. This failure appears to be occurring at the weakest interface along the butt seam (i.e., between primer and body filler or substrate and body filler). Whatever forces are causing the flex of the substrate (evidenced by the rivet heads) distorts the coatings. The coatings are going to separate at the weakest interface, which appears to be the body filler/substrate interface (figures 28 and 29).

Figure 28. ECS before paint removal, serial no. 630106, overhaul date 05/05.

This Patriot ECS unit was painted using the low-VOC, water-reducible wash primer at Letterkenny, and fielded at Fort Bliss. The two areas of concern are sections of the shelter where the walls were replaced. The walls were bonded using a polysulfide sealer and polyester filler. The filler material appeared to have a heavy film. Dry film thickness measurements (1 mil = 0.001 in) were taken at four different areas. Data is recorded in table 42. Due to high temperatures, the shelter walls expanded causing the paint filler to crack and peel along the butt joints where replacement wall sections meet older wall sections. A knife blade easily removed painted filler along the edges for laboratory analysis.

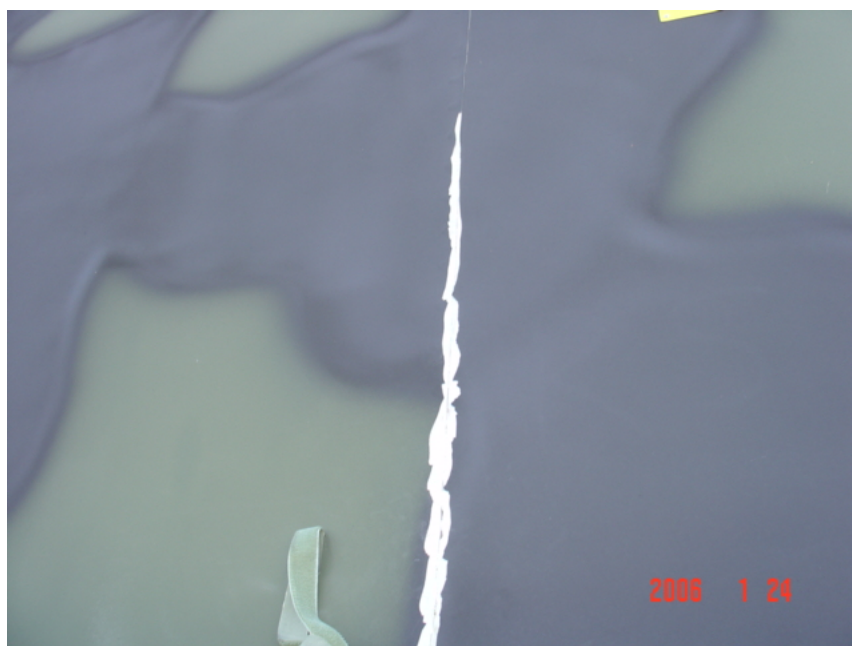
Figure 29. ECS after paint removal, serial no. 630106, overhaul date 05/05.
